# SERVICE BULLETIN

## CAB SERVICE & PARTS CORPORATION

Subject: ELECTRICAL - MODEL A-9

Description: READING LAMPS

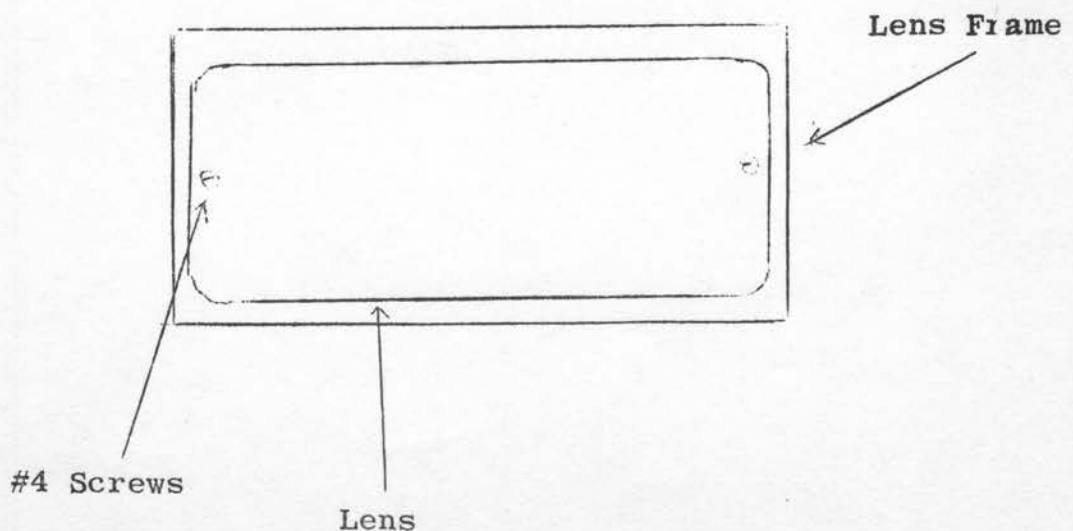
To prevent unnecessary loss of passenger and driver compartment reading light doors, the following procedure is recommended:

1. Drill a 1/16" hole through plastic door and into metal lamp housing at both ends.
2. Insert #4 (3/4" long) sheet metal screws.
3. Remove and replace screws whenever bulb replacement is required.
