SERVICE BULLETIN

CAB SERVICE & PARTS CORPORATION #58

Subject: REAR AXLE - MODEL A-9

Description: SERVICING THE POWR-LOK DIFFERENTIAL

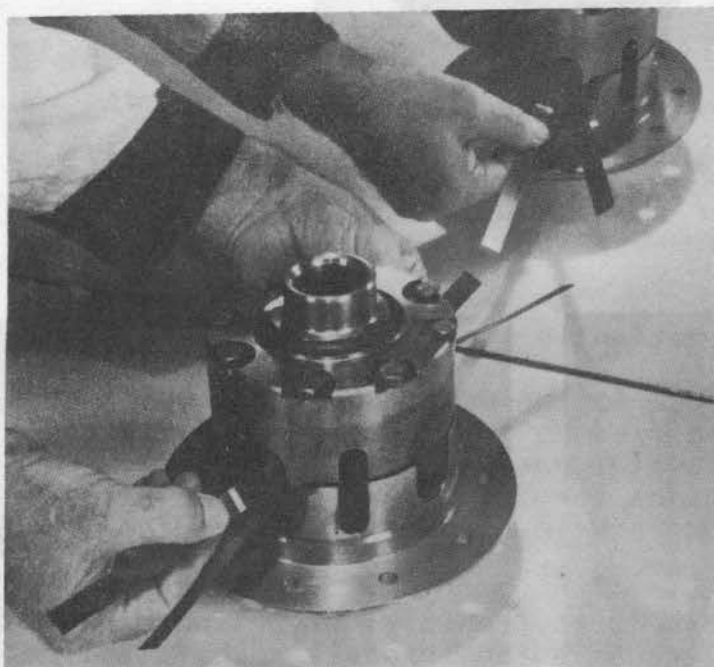
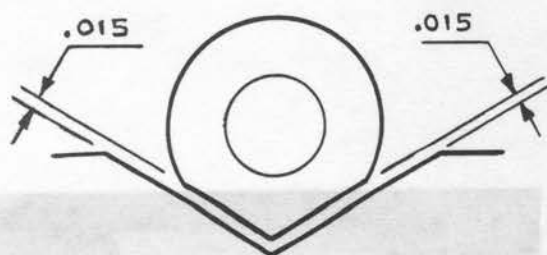
FIG. 1

1. Remove the differential case assembly from the axle housing.
2. Check the clearance between the pin "V" and the cam surface in the case. This must be done using shim stock or feeler gauges under both sides of the "v" on both ends of the pinion mate shaft at the same time.

NOTE: THIS INVOLVES PLACING FEELERS AT FOUR POSITIONS (see Figure #1).

3. As closely as possible, the same thickness feeler must be used at all four positions. The clearance or the maximum feeler thickness at each of the four positions should not exceed .015. Both pinion mate shafts should be checked in this manner.

MAXIMUM PERMISSABLE SHIM THICKNESS AT BOTH ENDS OF THE PIN AT THE SAME TIME.

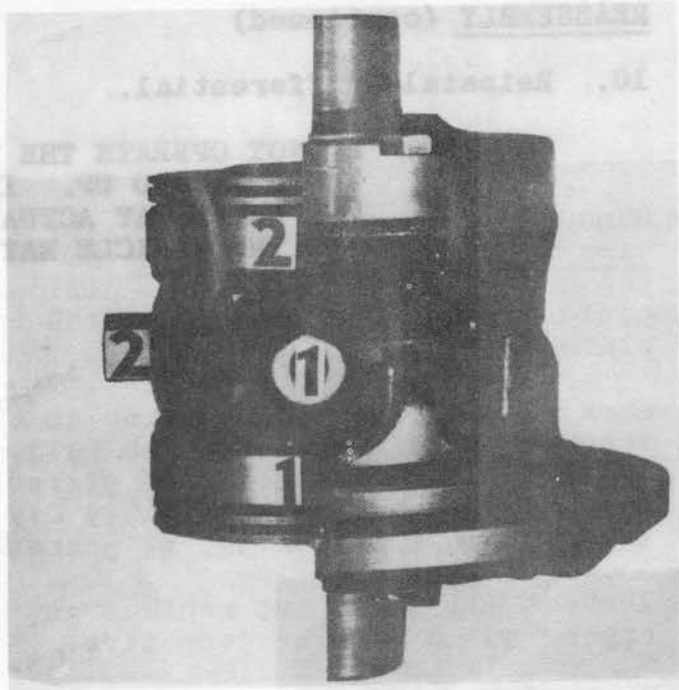
Fig. 2

As an example - let it be assumed that we used .020 shims under each side of the "V" and at each end of one cross pin and .015 shims under each side of the "V" and at each end of the other cross pin. Note that the clutch which is operated by the cross pin having the .020 clearance is in the opposite case half from the cam surface on which the pin operates. The same is true of the clutch operated by the pin having the .015 clearance (see Figure #2).

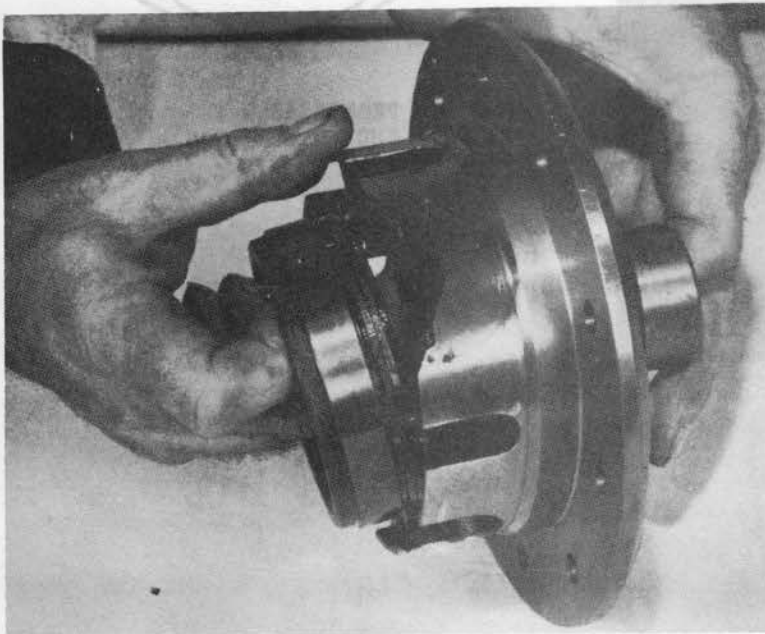
FIG. 3

4. Place the proper clutch ring and clutch assembly in the case half (see Figure #3).
5. Put the case half hub down on a bench. Put a side gear in the clutch ring and place the pinion mates and pinion mate shafts in the assembly. Make sure that the previously marked shaft corresponds with the mark in the case.

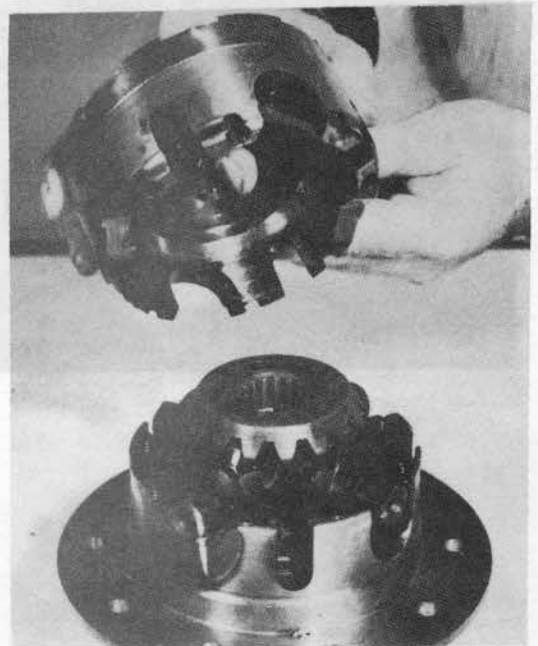
FIG. 4

4. Mark or scribe both halves of the case for ease of reassembly. Mark each pinion mate shaft so that upon reassembly the pins cam surface will match with the same "V" ramp in the case (note mark in Figure #4).

6. Place the other side gear on top of the assembly. Install the other clutch and clutch ring assembly in the other half of the case.
7. Assemble the two case halves as shown (see Figure #4).
